# NEWSLETTER VOL I-1

This issue of our newsletter will identify and discuss some common failures that occur in shell & tube heat exchangers, as well as corrective actions for prevention of each type of failure.

## “Mechanical Failure of Shell & Tube Heat Exchangers”

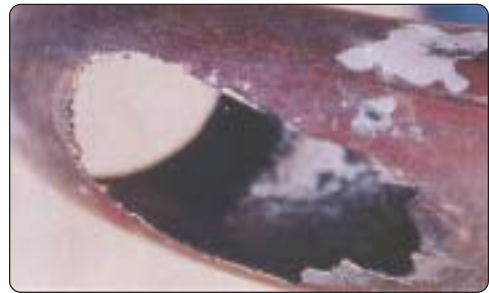
Fig. 1. Metal Erosion in U-bend.

Most metal erosion problems occur inside the tubes. The U bend of U-type heat exchangers and the tube entrances are the areas most prone to erosion. Fig. 1 shows the metal loss in a U bend caused by high-temperature water flashing to steam.

Excessive fluid velocity on either the shell or tube side of the heat exchanger can cause damaging erosion as metal wears from the tubing. Any corrosion already present is accelerated as erosion removes the tube's protective films, exposing fresh metal to further attack.

Maximum recommended velocity in the tubes and entrance nozzle is a function of many variables, including tube material, fluid handled, and temperature. Materials such as steel, stainless steel, and copper-nickel withstand higher tube velocities than copper. Copper is normally limited to 7.5 fps; the other materials can handle 10 or 11 fps. If water is flowing through copper tubing, the velocity should be less than 7.5 fps when it contains suspended solids or is softened.

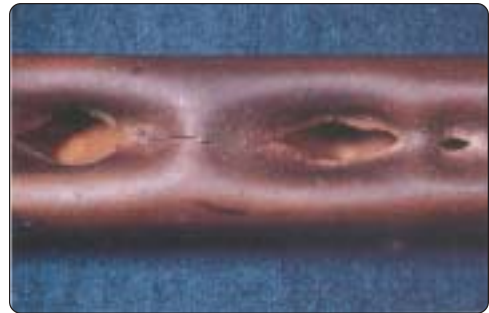
Fig. 2. Tube Damage from Steam Hammer.

Fluid flow control valves that open or close suddenly also produce water hammer. Modulating control valves are preferable to on-off types. Vacuum breaker vents must be provided if condensables are handled in either the shell or tubes; they prevent steam hammer damage resulting from condensate accumulation. Fig. 2 shows typical tube damage caused by steam hammer. In this case, condensate accumulated in the shell and rapidly accelerated, producing a high-pressure shock wave that collapsed the tube and caused the tear holes.

Damaging pressure surges can result from a cooling water flow interruption. The stagnant cooling water is heated enough to generate steam, and the resumption of the flow causes a sudden condensing of the steam and produces a damaging pressure surge, or water hammer. Cooling water flow should always be started before heat is applied to the exchanger.

Properly sized steam traps with return lines pitched to a condensate receiver or condensate return pump should be installed to prevent this type of damage.

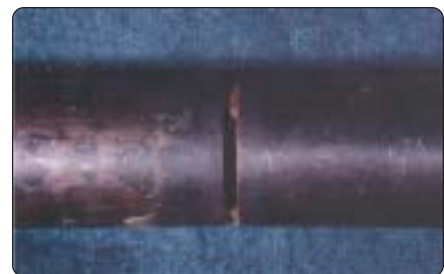
Fig. 3. Velocity-induced vibration of tube.

Shell-side fluid velocities in excess of 4 fps can induce damaging vibrations in the tubes, causing a cutting action at support points with baffles, Fig. 3. Velocity-induced vibrations can also cause fatigue failures by work hardening the tubing at baffle contact points or in U-bend areas until a fatigue crack appears.

Excessive vibration from equipment such as air compressors or refrigeration machines can cause tube failures in the form of a fatigue stress crack or erosion of tubing at the point of contact with baffles. Heat exchangers should be isolated from this type of vibration.

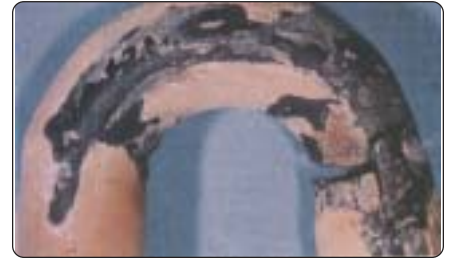
Fig. 4. Thermal Fatigue Failure in U-bend.

Fig. 4 shows an example of thermal fatigue. The temperature difference causes tube flexing, which produces a stress that acts additively until the tensile strength of the material is exceeded and it cracks. The crack usually runs radially around the tube, and many times results in a total break. In other cases, the crack occurs only halfway through the tube and then runs longitudinally along it.

Tubing, particularly in the U-bend area, can fail because of fatigue resulting from accumulated stresses associated with repeated thermal cycling. This problem is greatly aggravated as the temperature difference across the length of the U-bend tube increases.

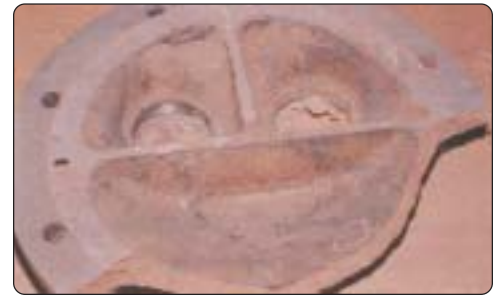
Fig. 5. Thermal expansion failure of cast iron heat exchanger head.

In steam-heated systems, cooling down or condensing residual steam in the shell after the steam control valve closes continues to heat water or other fluids on the tube side. Continued heating causes thermal expansion, which creates pressures far in excess of the strength of tube sheets, cast heads, and other heat exchanger components. Cast iron parts usually fracture because of lack of ductility; steel tube sheets become bowed or permanently distorted because the material's yield point is exceeded. Fig. 8 shows thermal expansion failure of a cast iron heat exchanger head.

Relief valves are installed in the heated fluid system to prevent this kind of failure. It is also advisable to provide some means to absorb fluid expansion. For example, installing a tank in the heated fluid system prevents periodic discharge of relief valves, which results in loss of system fluid and places an undue burden on the valve. These devices are installed between the heat exchanger and any shutoff or control valves.

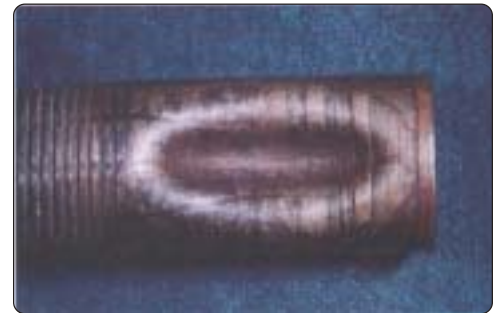
Fig. 6. Collapse of evaporator tube because of freeze-up.

For example, assume a chiller has improper settings or malfunctioning controls that cool the water to a point below its freezing point. Ice forms and exerts tremendous pressure in the tubing, which causes it to rupture or collapse. Collapse in an evaporator, Fig. 6, usually occurs near the tube sheet where the tube is not protected by an inner spline.

These failures are most common in evaporators or condensers; however, they can occur in any heat exchanger in which temperatures drop below the freezing point of either fluid in the unit. Freeze-up results from failure to provide thermal protection, a malfunction of the thermal protection control system or protective heater device, improper drainage of the unit for winter shutdown, or inadequate concentration of antifreeze solutions.

Freeze-up failure in a condenser tube can also occur when cooling water was circulating inside the tube, refrigerant was condensed on the externally finned surface, and the unit was not properly drained for winter shutdown. The tube distortion indicates that it was exposed to excessive pressure caused by the freezing water.

This type of failure is also caused by the sudden release of refrigerant pressure from the condenser. The sudden release caused by a line break or relief valve discharge suddenly drops the pressure below the boiling point of the refrigerant. Boiling extracts heat from water in the tubes and the liquid freezes.
